2. 27115 Meadowoods Drive (Reported Concern 18)

5. Mettawa Lane (Reported Concern 5)

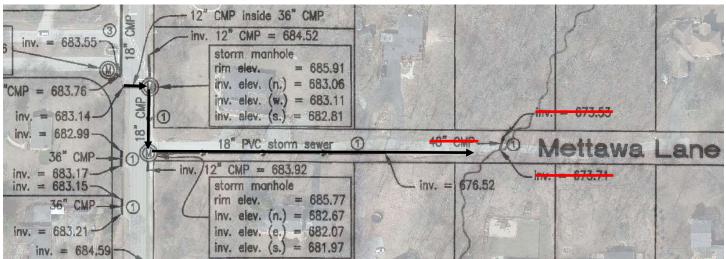
To address the remaining overflow of Bradley Road at Oasis Park and at Mettawa Lane (depicted in Reported Concern 5), it is recommended that the 12-inch to 18-inch pipe system conveying flows from the ditch system along the western side of Bradley Road to the ditch system along Mettawa Lane be upsized. To accommodate this flow, and considering the limitations in increasing ditch capacity, it is recommended that new storm sewer be installed to convey flows.

Ditch west of Bradley Drainage System to Mettawa Lane

The Village has been involved in ongoing discussions about the reconstruction of Mettawa Lane to comprehensively address stormwater and improve the roadway. It is recommended that any stormwater improvements, including upsizing the identified 12-inch to 18-inch piped system along Mettawa Lane be implemented in conjunction with roadway improvements for infrastructure maintenance access. Additionally, increasing capacity through this system would require the stabilization of the drainageway from Mettawa Lane downstream to the Interstate 94 culvert.

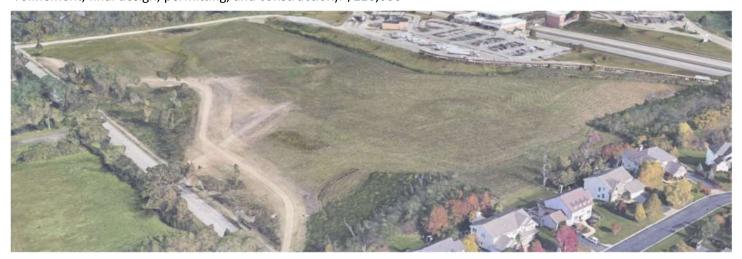
Oasis Park, August 2018

In the concept for Oasis Park, creation of approximately 10-acre-feet of storage could be provided at an elevation below 685 (the approximate lowest elevation of the Oasis Service Road) in a functional manner to preserve the integrity of the park site and this reach of the Mettawa Trail. A low flow channel is proposed to convey the drainage through this site in most conditions and low flow storm events, likely represented by the 2-year event. Natural riffle structures would function to restore and protect grade, while the alignment would restore the natural meanders of a small stream. A terrace would be constructed to convey events in the 5-year to 10-year recurrence interval range. Capacity would be designed for flows to access this terrace, supporting a unique native plant community and restoring
